REPORT ROYAL COMMISSION

QUEBEC BRIDGE
INQUIRY
1908

REPORT ON DESIGN OF QUEBEC BRIDGE

C. C. SCHNEIDER

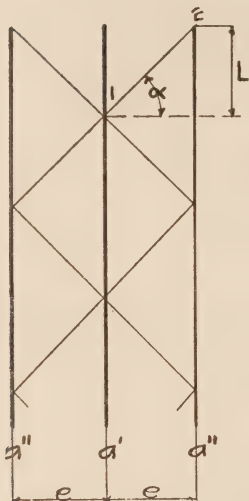
Fig. 19.

2.—Columns with 3 Webs: (Fig. 19.)

Required area of column $a = a' + 2a''$, where a' and a'' are the actual areas of the ribs reduced in proportion of the total required area 'a' to the actual area.

The longitudinal shear S' between two ribs for one panel length L has to be taken up by the diagonal 1-2 of that panel.
